**FISH PASSAGE RESTORATION:
POST CONSTRUCTION MITIGATION
MONITORING REPORT
YEAR 5**

July 2008

Contract Number PG3445173

NORTHWEST BRANCH AND SLIGO CREEK

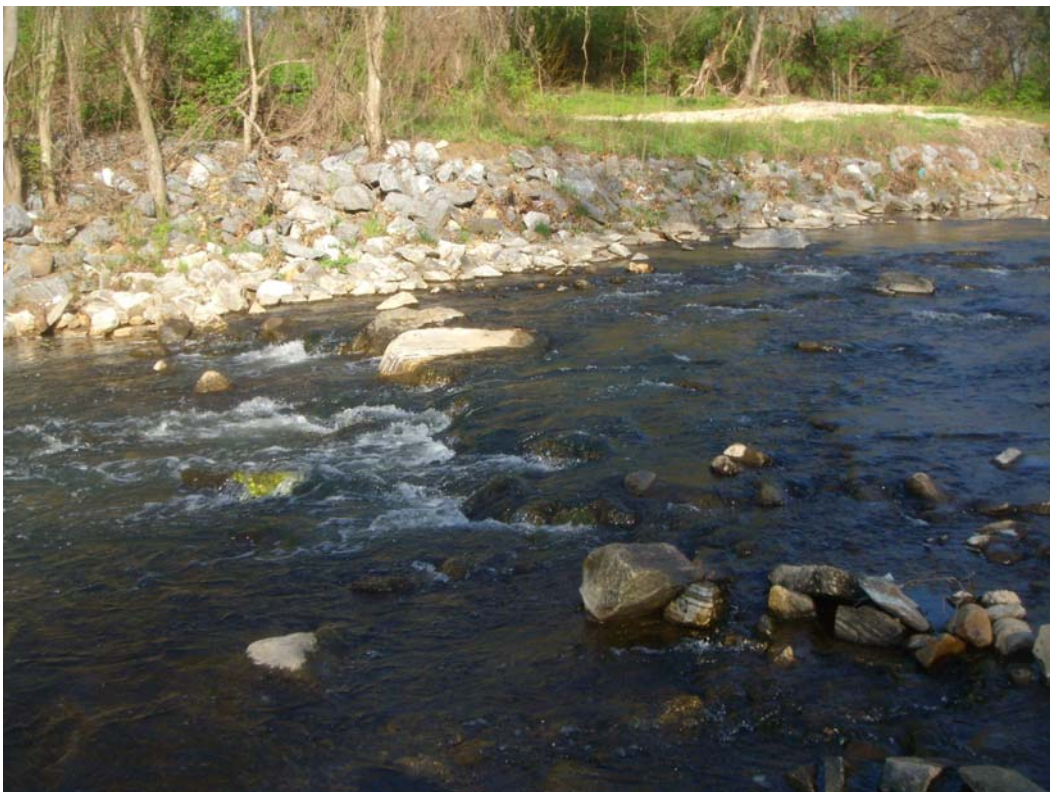
The RGC structure at NW-5 shows some signs of instability and cause for concern. The primary concerns include re-armoring of an exposed gas line, a failing gabion wall downstream of the structure, and a grade elevation change (nick point) at the terminus of the structure. Photos are provided in *Appendix A*. As a result of these concerns, a complete survey was completed for NW-5 in 2008.

Northwest Branch– 5 looking downstream, April 2008
