SCA (Stream Corridor Assessment) Survey Report

Inspector: Masaya Maeda
Anacostia Watershed Society
Mar 30, 2004

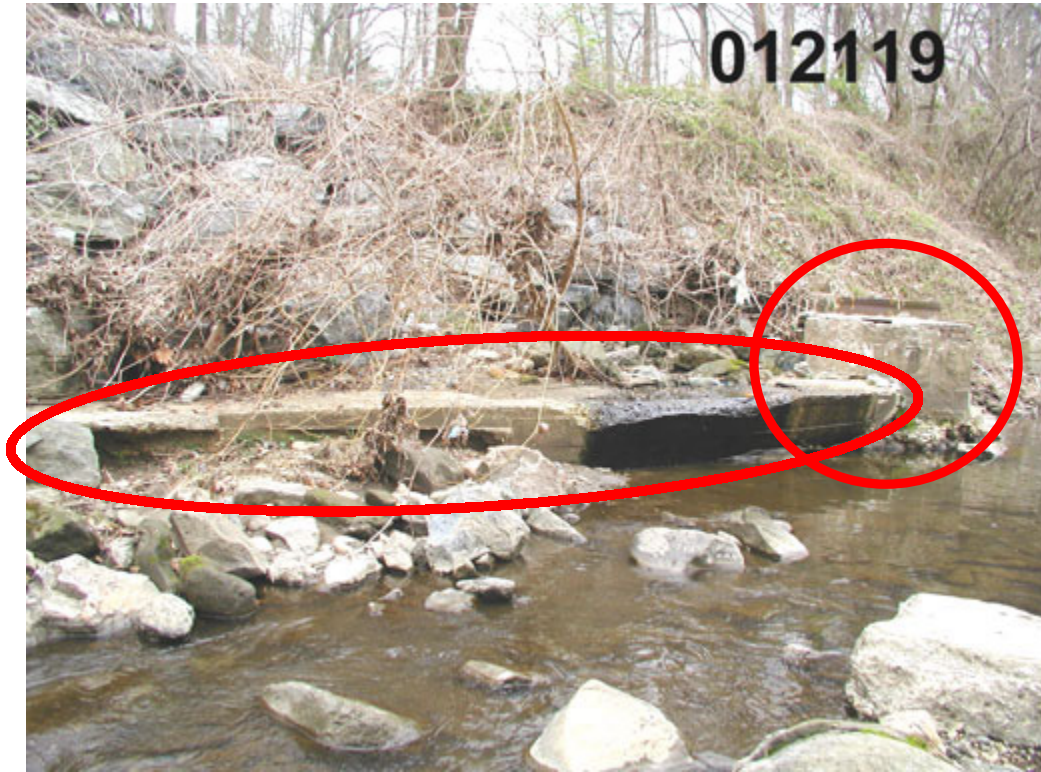
(GPS data: 38.98285N, -76.99949W)

- Sewer pipe running along the stream and manhole stack.
- The stack has cracks (see picture down below) on top of it and one can see inside of stack.
- Potential leakage problem, especially during high flow events
- Potential problem of damage by a high flow event and possible sewage release

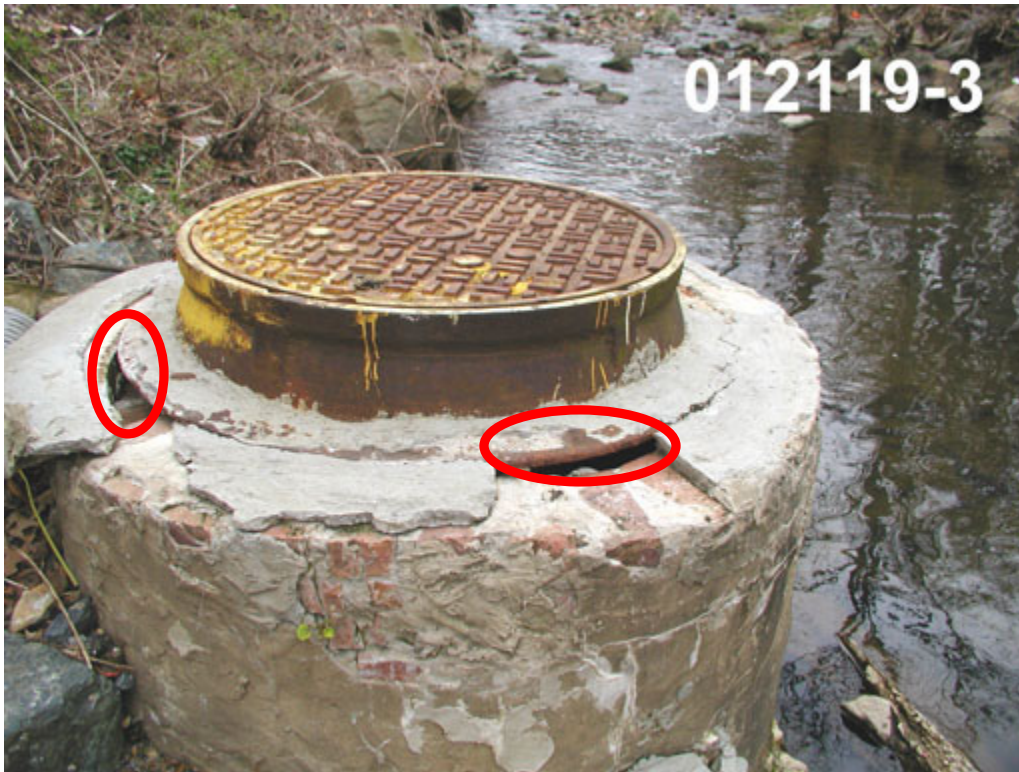
- Encircled: major cracks

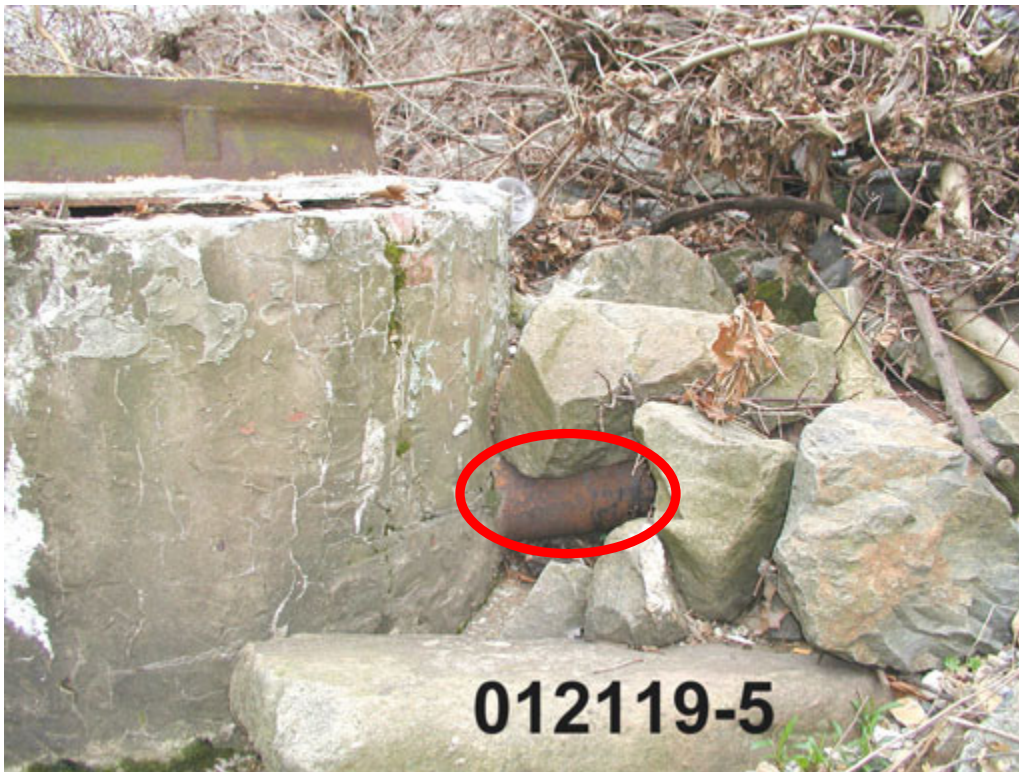
- Connecting pipe is exposed

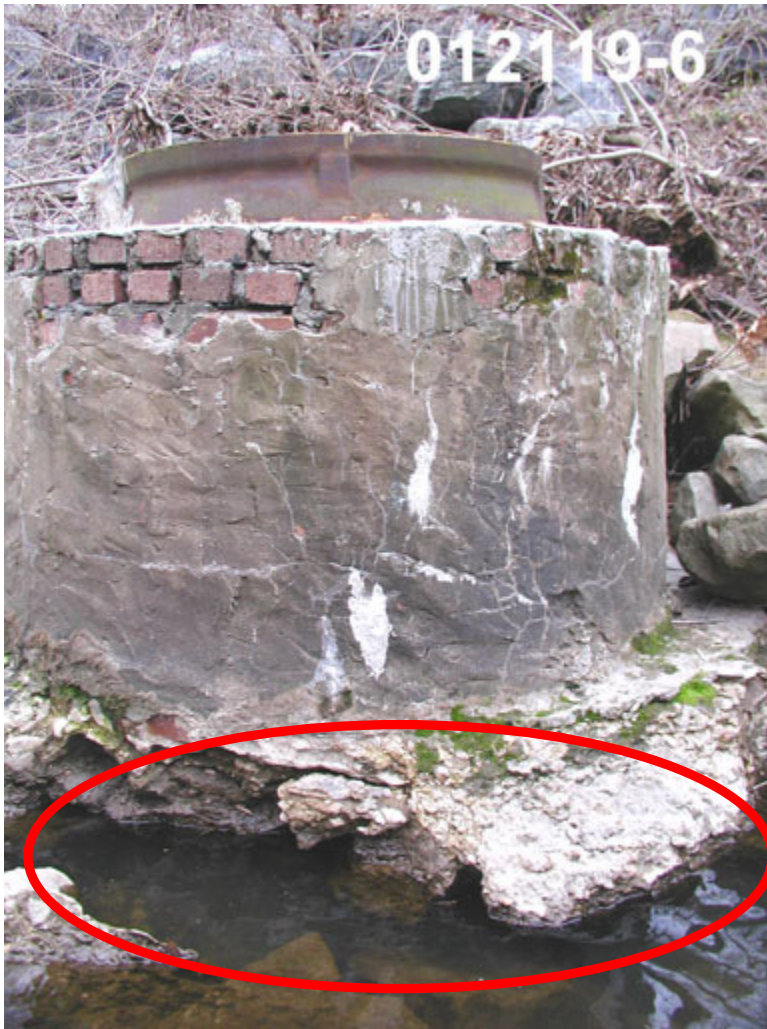
- Being undermined
