SCA (Stream Corridor Assessment) Survey Report

Inspector: Masaya Maeda
Anacostia Watershed Society
Apr. 28, 2004

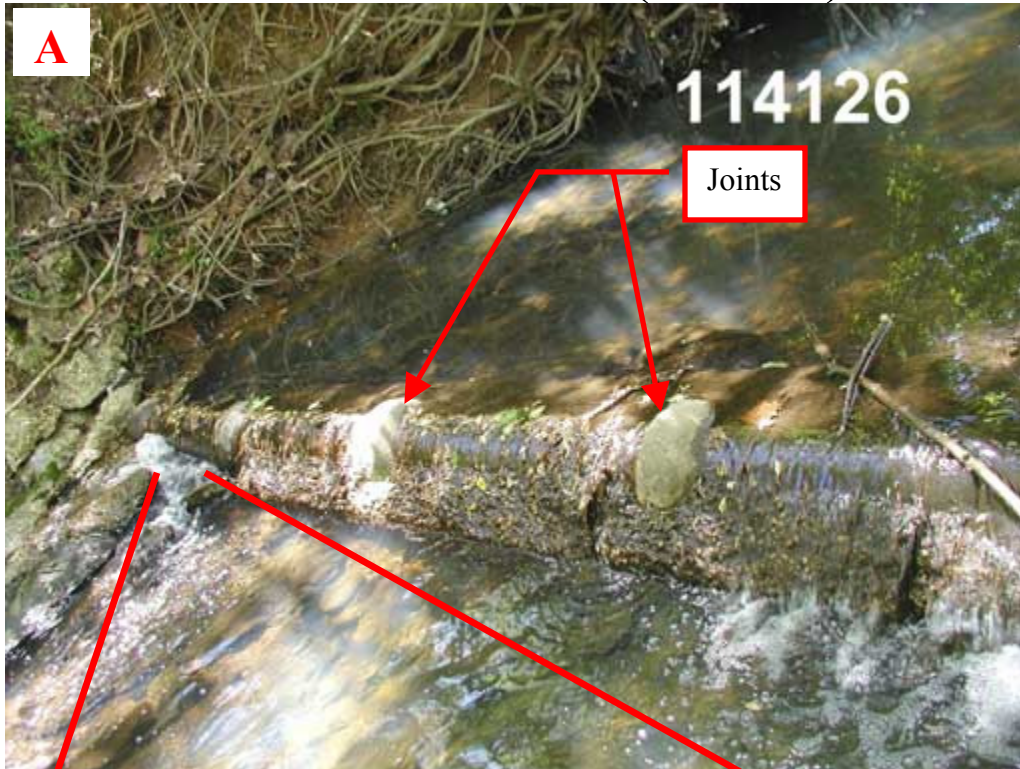
Pictures for site A (114126)

This exposed pipe is also a fish barrier.

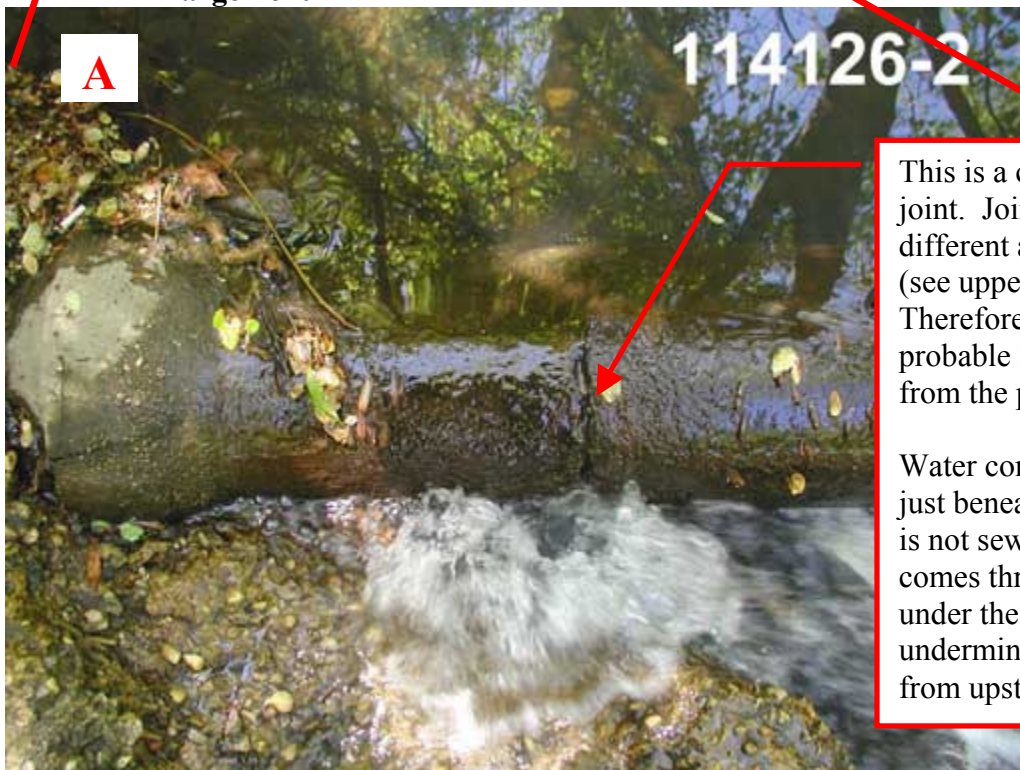
Enlargement

This is a crack not a joint. Joints have different appearance (see upper picture). Therefore, there is a probable leakage from the pipe.

Water coming out just beneath the pipe is not sewage. It comes through under the undermined pipe from upstream side.

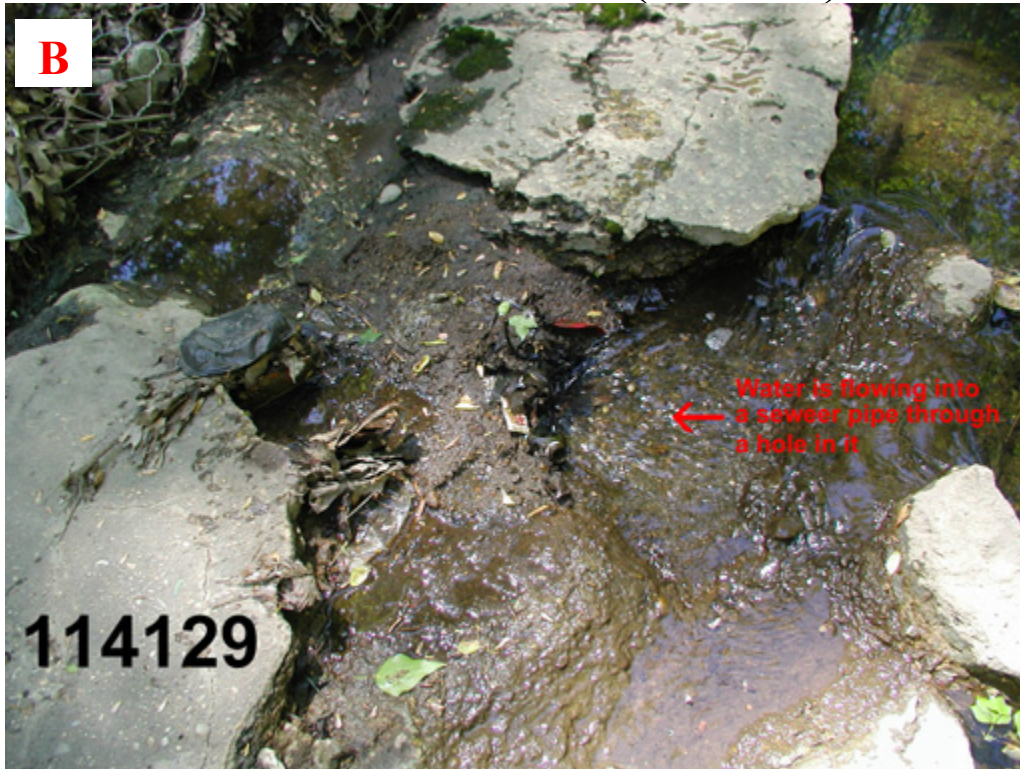
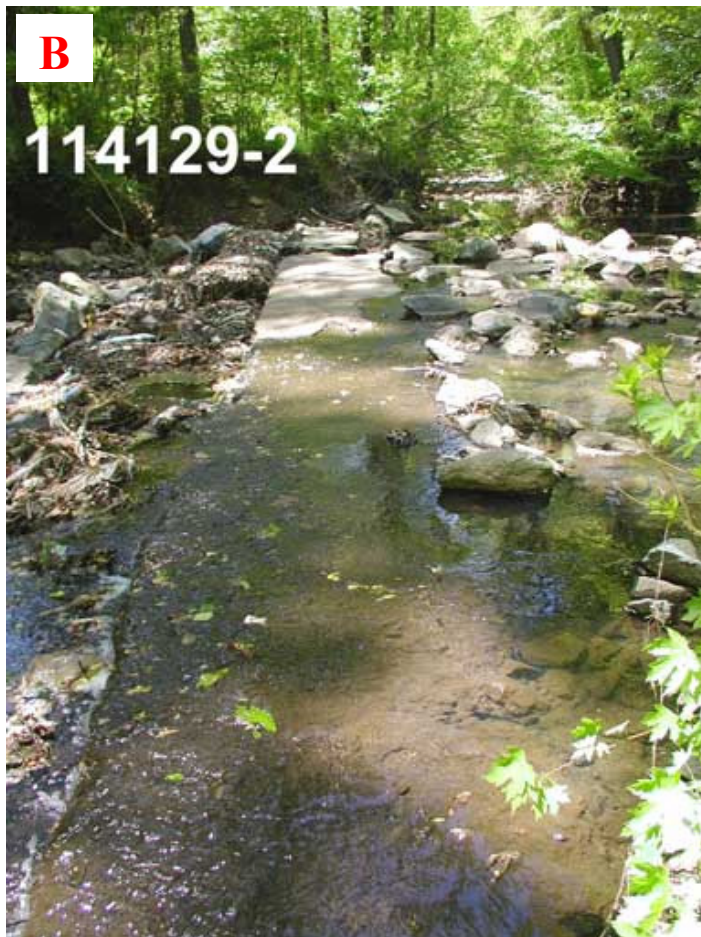
Pictures for site B (114129)

This big exposed pipe (the diameter is about 42 inches) has a hole in it allowing river water into the pipe (see upper picture). Leakage could not be seen with naked eyes but there is a strong sewage smell around the pipe. The smell is so strong that I even felt sick.

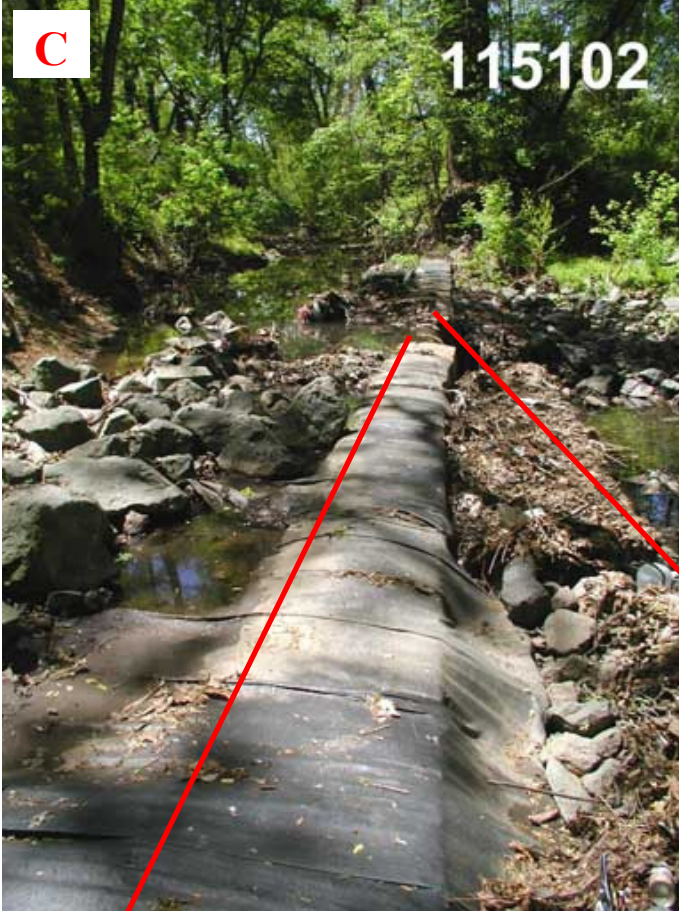
Pictures for site C (115102)

There is no clear sign of leakage with naked eyes. However, the highly exposed area (see lower picture) is fragile. It is likely that a hit from a cobble could break the pipe. This is also a fish barrier.
