# SCA (Stream Corridor Assessment) Survey Report

Inspector: Masaya Maeda  
Anacostia Watershed Society  
Apr. 07, 2004

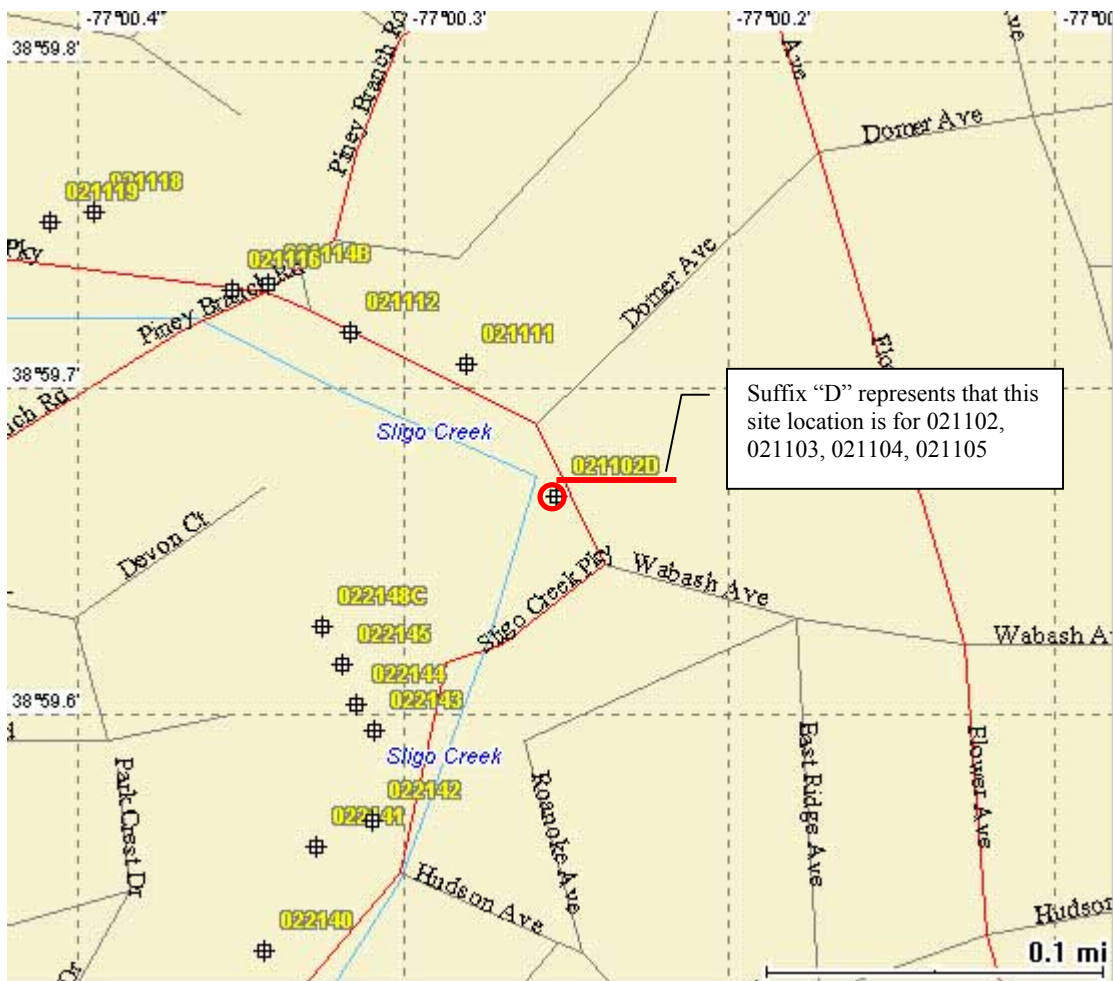
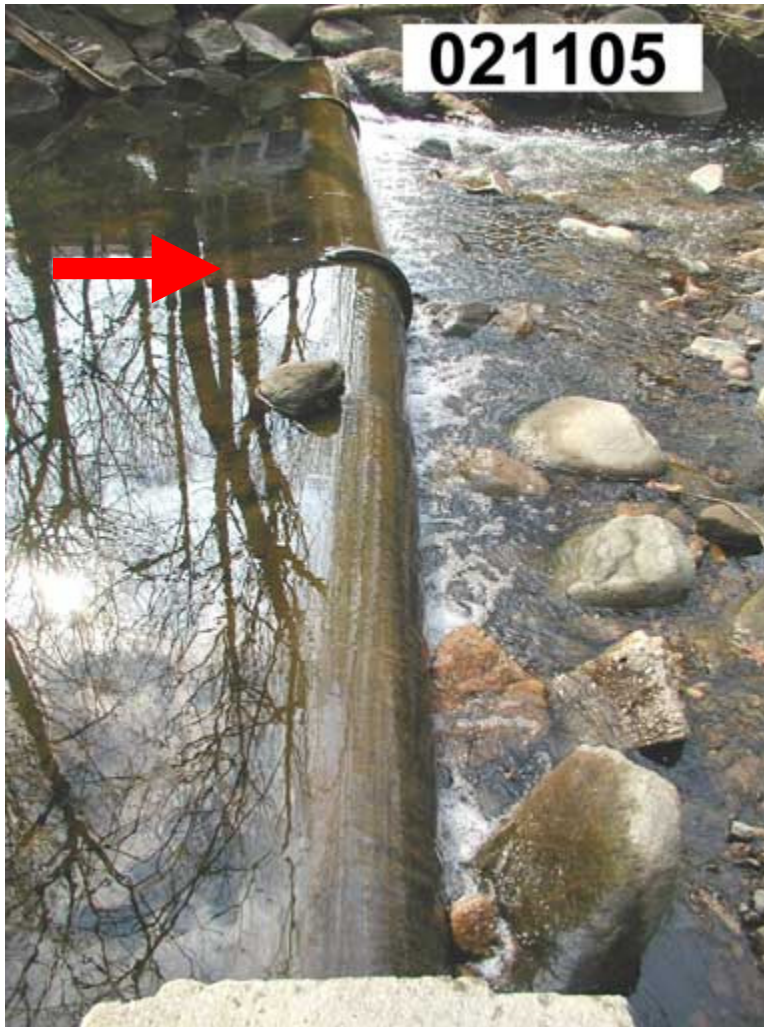
021105

Riverbed upstream of an exposed pipe is pushing the pipe and the pipe is in danger of being disconnected. It is likely that there is leakage, though it cannot be seen clearly with naked eye. This pipe is also a fish barrier.
