IDDE Monitoring in Sligo Creek

Friends of Sligo Creek

Lori Lilly

July 20, 2011

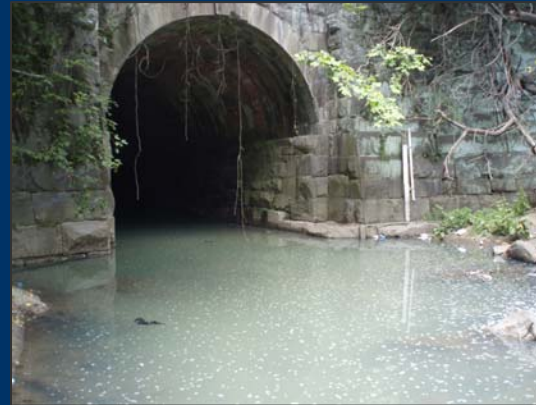
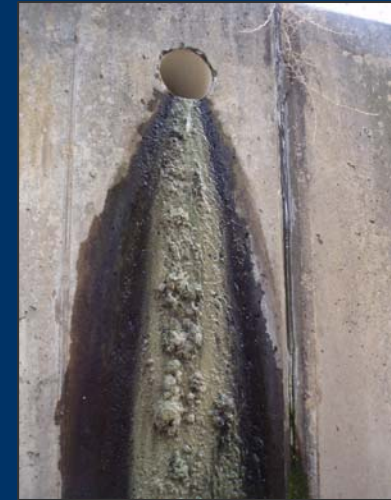
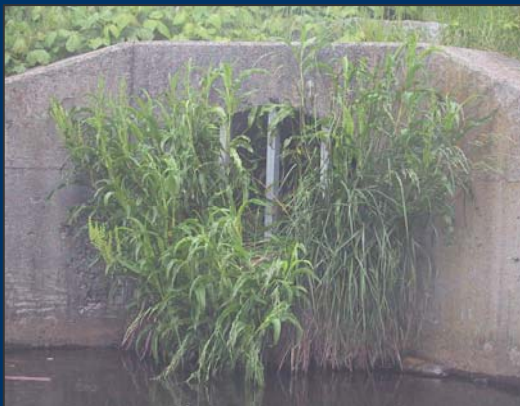
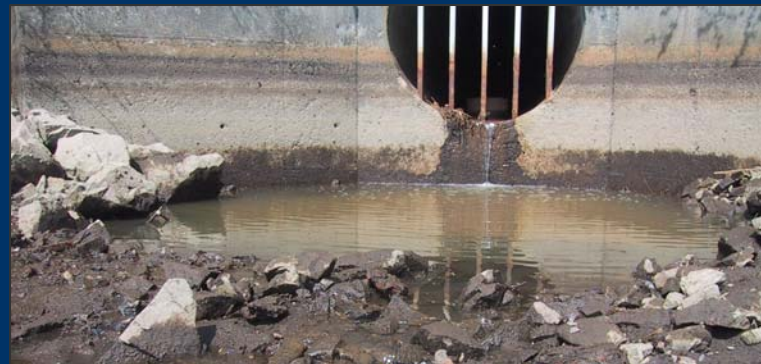
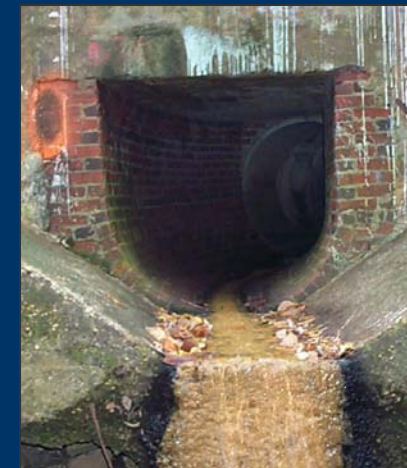
Outfall Reconnaissance Inventory (ORI) Qualitative Assessment

- ▶ Outfall Damage
- ▶ Deposits/Stains
- ▶ Abnormal Vegetation
- ▶ Poor Pool Quality
- ▶ Pipe Benthic Growth

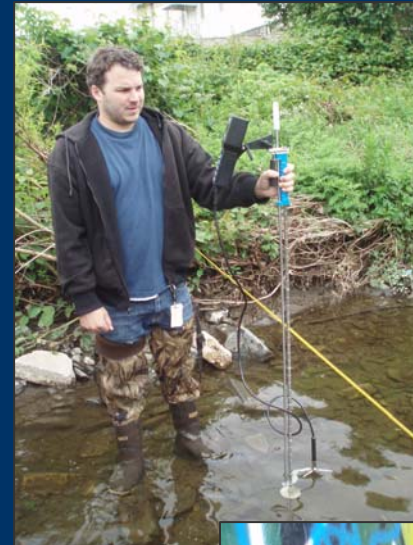
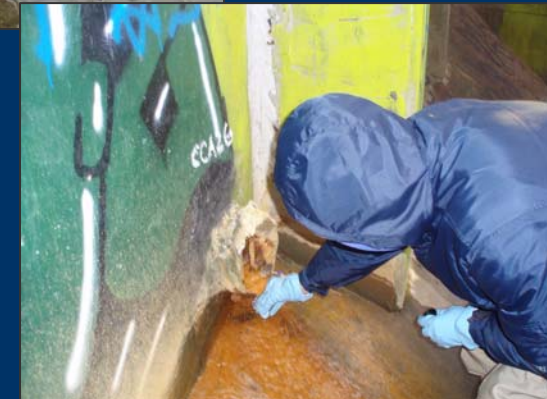
Outfall Reconnaissance Inventory (ORI) Quantitative Assessment

Parameters Analyzed
In the field	Ammonia
Sample 1	Fluoride
	Anionic Surfactants
	Potassium
Sample 2	Total Nitrogen
	Total Phosphorus
Sample 3	E. coli and Total coliform

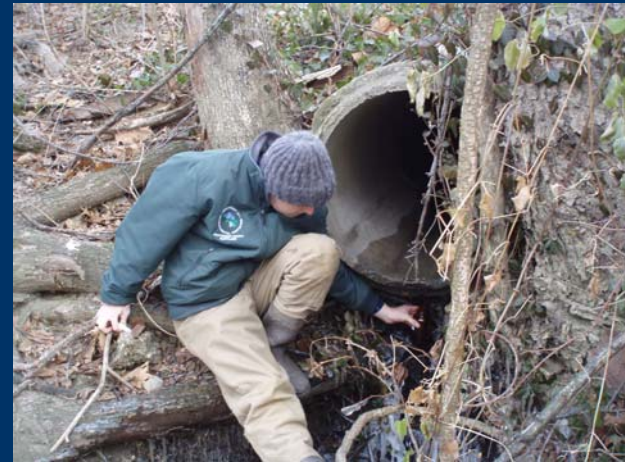
Field Work Summary

- ▶ Four days in the field throughout January, 2011
- ▶ 10 miles walked in Sligo Creek in Montgomery County
- ▶ 213 outfalls assessed
- ▶ 4 In-stream measurements
- ▶ 14 volunteers contributed 114 hours over field sampling period

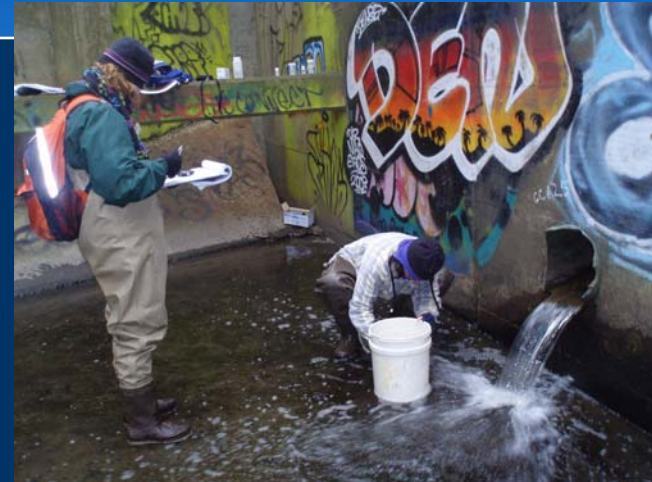
Outfall Summary

- ▶ Flowing outfalls: 58/213 (27%)
- ▶ Mapped outfalls: 45/213 (21%)
- ▶ Overall hits for flowing outfalls: ~80%
- ▶ Field hits for ammonia (>0.1 mg/l): 35/58 (60%)
- ▶ Hits for fluoride (>0.25 mg/l): 17/58 (29%)
- ▶ Hits for detergents (>0.25 mg/l): 24/58 (41%)
- ▶ Storm drain investigations: 23

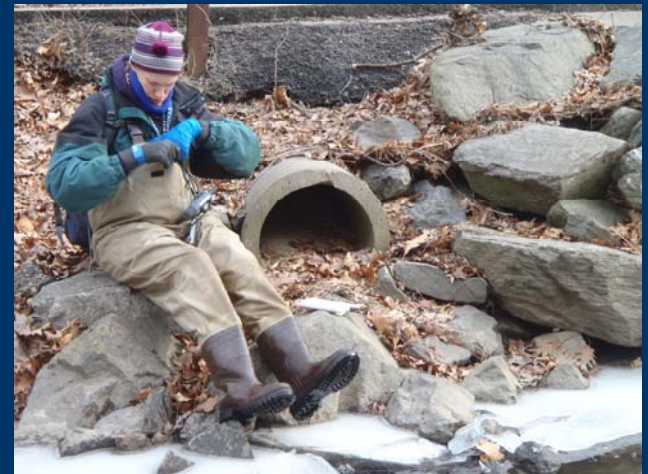
Percentage of Total E.coli in Sligo Creek Outfalls

- ▶ Outfalls with E. coli above EPA threshold for contact recreation (235 CFU/100ml): 14/58 (24%); range – up to 26,000 CFU/100ml
- ▶ Outfalls with total coliform >235 CFU/100ml: 38/58 (66%); range – up to 30,000 CFU/100ml

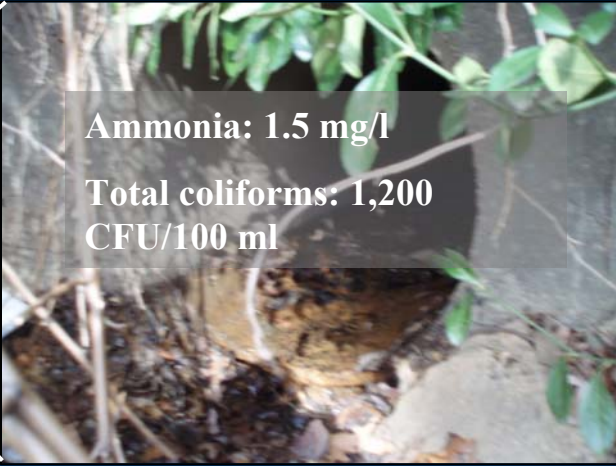
Ammonia: 1.5 mg/l
 Total coliforms: 1,200
 CFU/100 ml

- Tracking team visited wrong site, however, they found two other illicit discharges
- Manhole investigation revealed a likely direct connection between a rehab center and the storm drain (ammonia: 0.87 mg/l; lab QC: OR)
- Detected additional flow from 7513 Carroll Ave; discharge traveled via the street and appeared to be from a sump pump although frequency was high for a sump pump
- Field ammonia: >1 mg/l and lab QC: OR

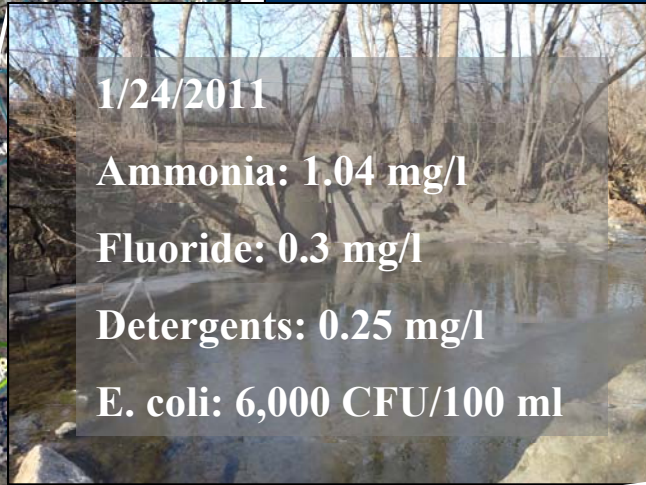
- Four site visits to this outfall
- Dye testing in school and video inspection revealed no connections
- Two sources of flow identified from Mansfield and between Mansfield and Dale on Wayne
- TN – 6.9 lb/day; TP – 0.16 lb/day
- Cumulative load as of 7/20/2011 = 1,000 lbs + ? TN & 23 + ? Lbs TP
- 38 million gallons + ?

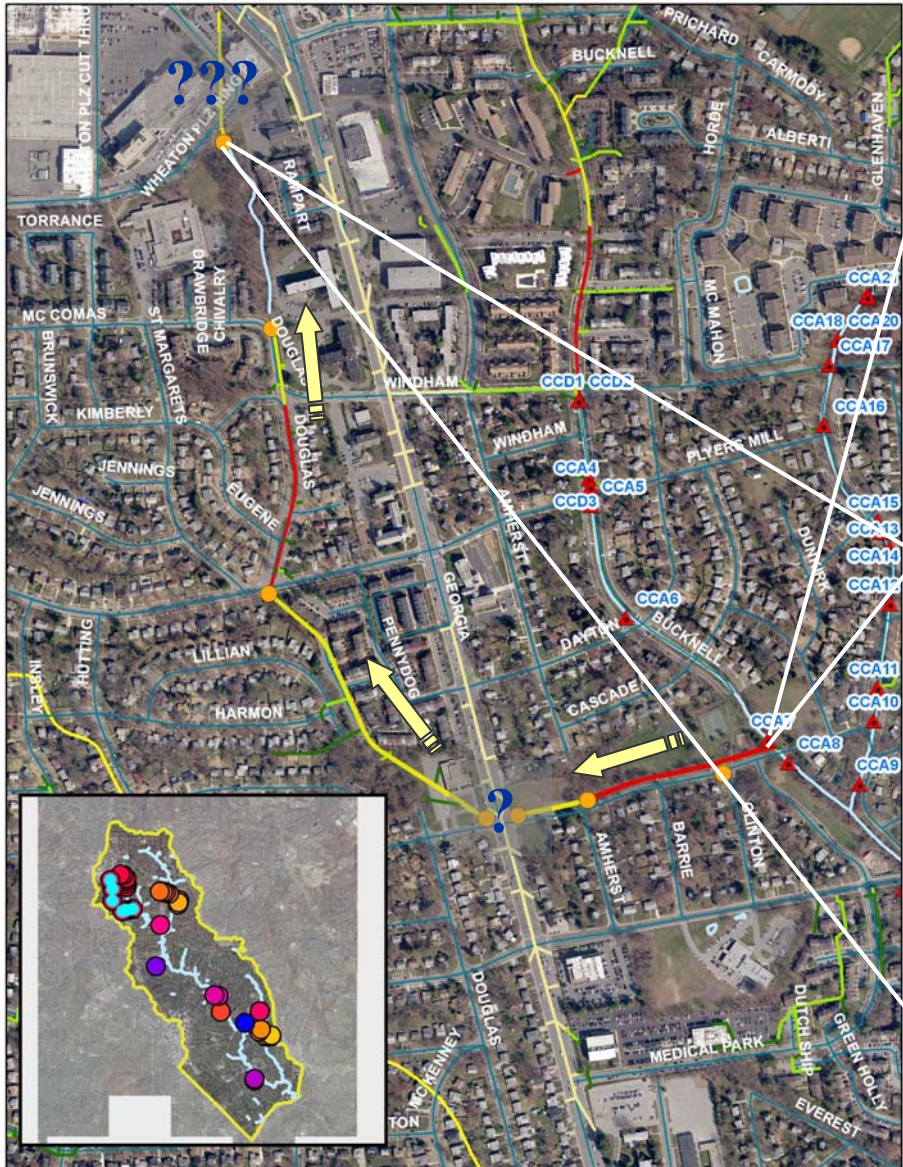
1/10/2011
 Ammonia: 3.62 mg/l
 Potassium: 31 ppm
 Detergents: 0.75 mg/l
 E. coli: 13,000 CFU/100 ml
 Flow: 32,344 gallons/day

Original total nitrogen load: 1.47 lb/day
 As of 7/20/2011 -
 ~4.8 million gallons + ?
 Total nitrogen load = 216 lbs + ?

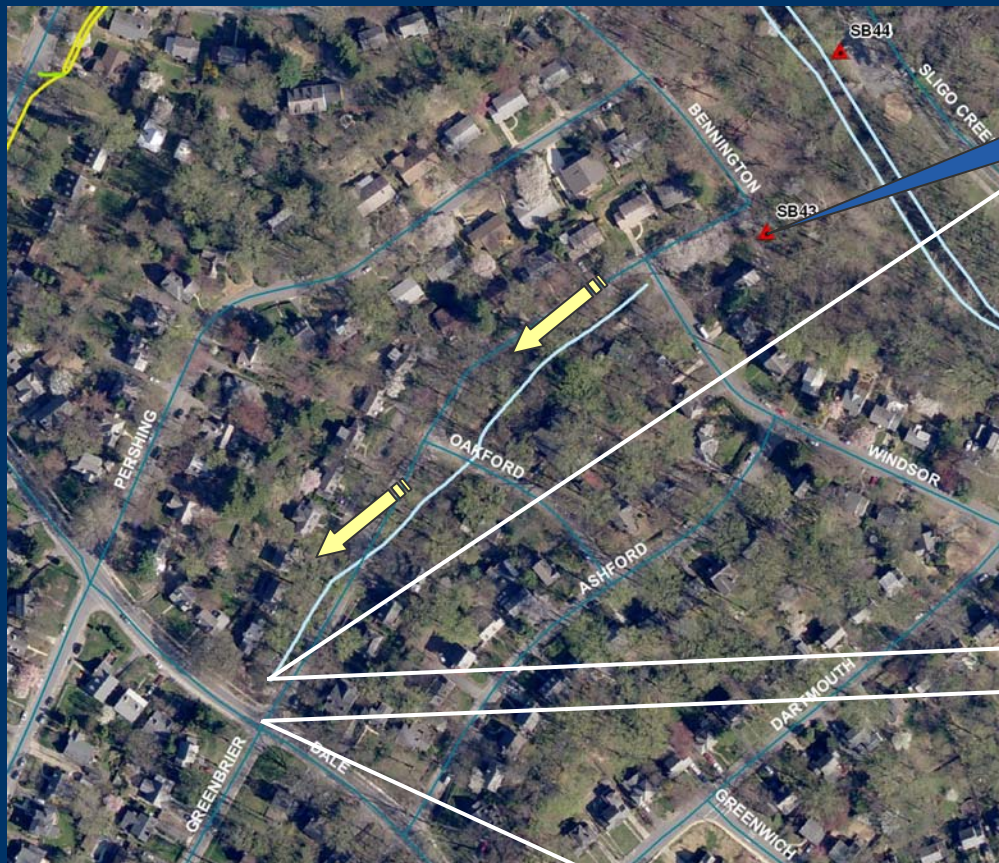
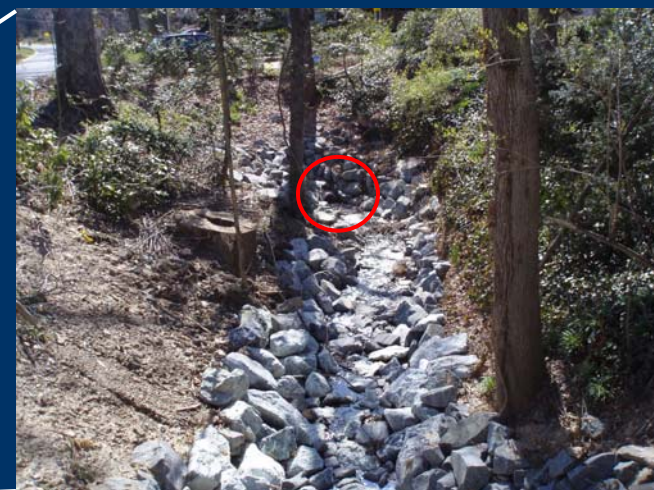
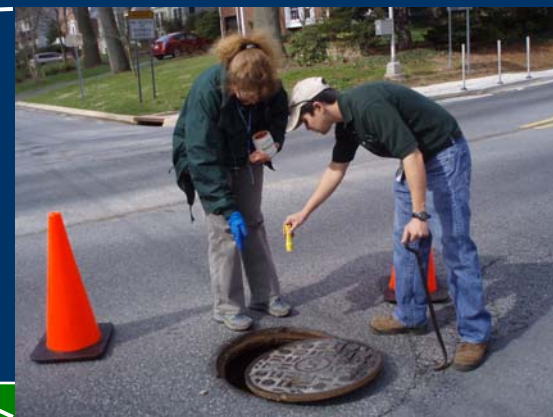
SB43

Ammonia – 0.32 mg/l
Potassium – 17 ppm
Detergents – 1.5 mg/l
E. Coli – 1,600 CFU/100 ml
