**FISH PASSAGE RESTORATION:
POST CONSTRUCTION MITIGATION
MONITORING REPORT
YEAR 5**

July 2008

Contract Number PG3445173

NORTHWEST BRANCH AND SLIGO CREEK

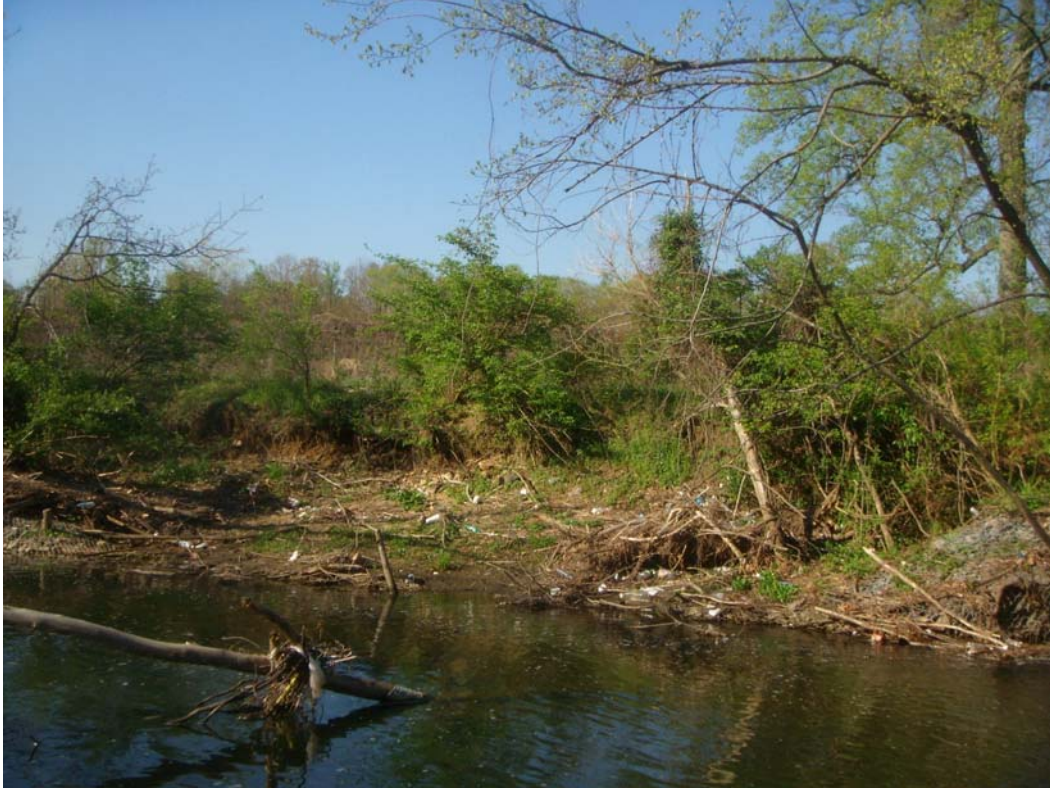
The monitoring data shows that the majority of the sites have remained stable, exhibiting no discernable loss of integrity. However, NW-5 continues to have structural issues, and the notch in the sheet pile weir at SC-1 is frequently clogged with debris. A full survey of NW-5 was conducted again this year because of structural issues identified in the visual assessment. Concerns about NW-5 from the 2007 report included exposed gas lines in the channel, dislodged concrete mattresses which previously covered the gas lines, and a failure of the right gabion wall downstream of the structure. Within the past year, a nick point developed at the bottom of the structure and migrated upstream about eight feet. Visual observations of the right bank indicate that the failed gabion wall has moved downstream slightly. The bank behind the gabion wall appears stable. Neither the nick point or failed gabion wall are acting as blockages to fish migration; however, they require continued attention.

Northwest Branch – 5 Collapsed gabion and bank, April 2008

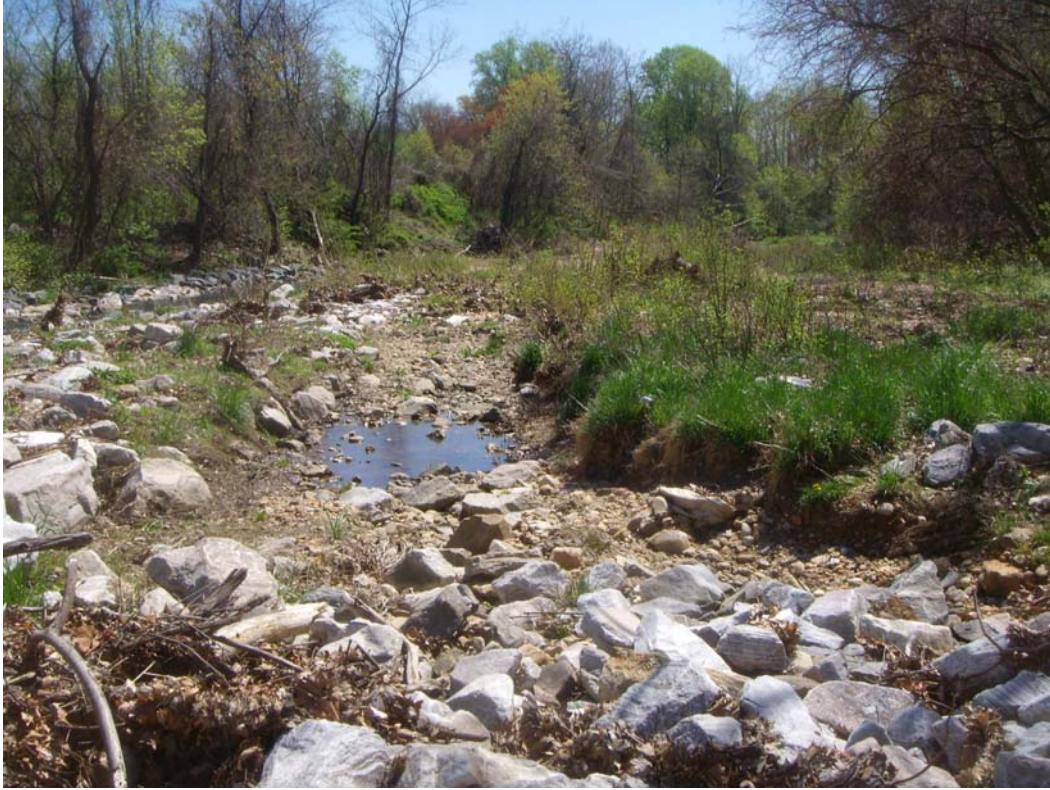
Sligo Creek 1 – scour channel along right bar, April 2008
